NASA Engineering and Safety Center Report	Document #: RP-04-11/ 04-004-E	Version: 1.0
Title:	Orbiter LH₂ Feedline Flowliner Cracking Problem Independent Technical Assessment (ITA) Report		Page #: 1 of 130

INDEPENDENT TECHNICAL ASSESSMENT OF THE ORBITER LH₂ FEEDLINE FLOWLINER CRACKING PROBLEM

FINAL REPORT

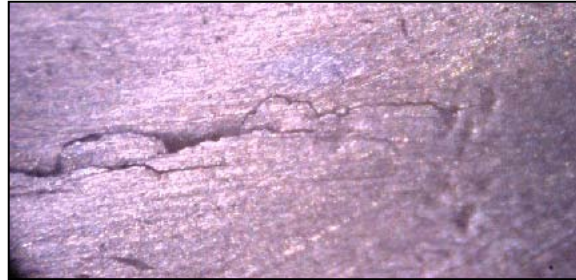
Figure 5.0-5. Crack Bifurication

- e. Some cracks exhibited bifurcation (see Figure 5.0-5).
